Coastal Protection and Restoration Authority of Louisiana

2019 Operations, Maintenance, and Monitoring Closeout Report

Fritchie Marsh Restoration (PO-06)

State Project Number PO-06
Priority Project List 2

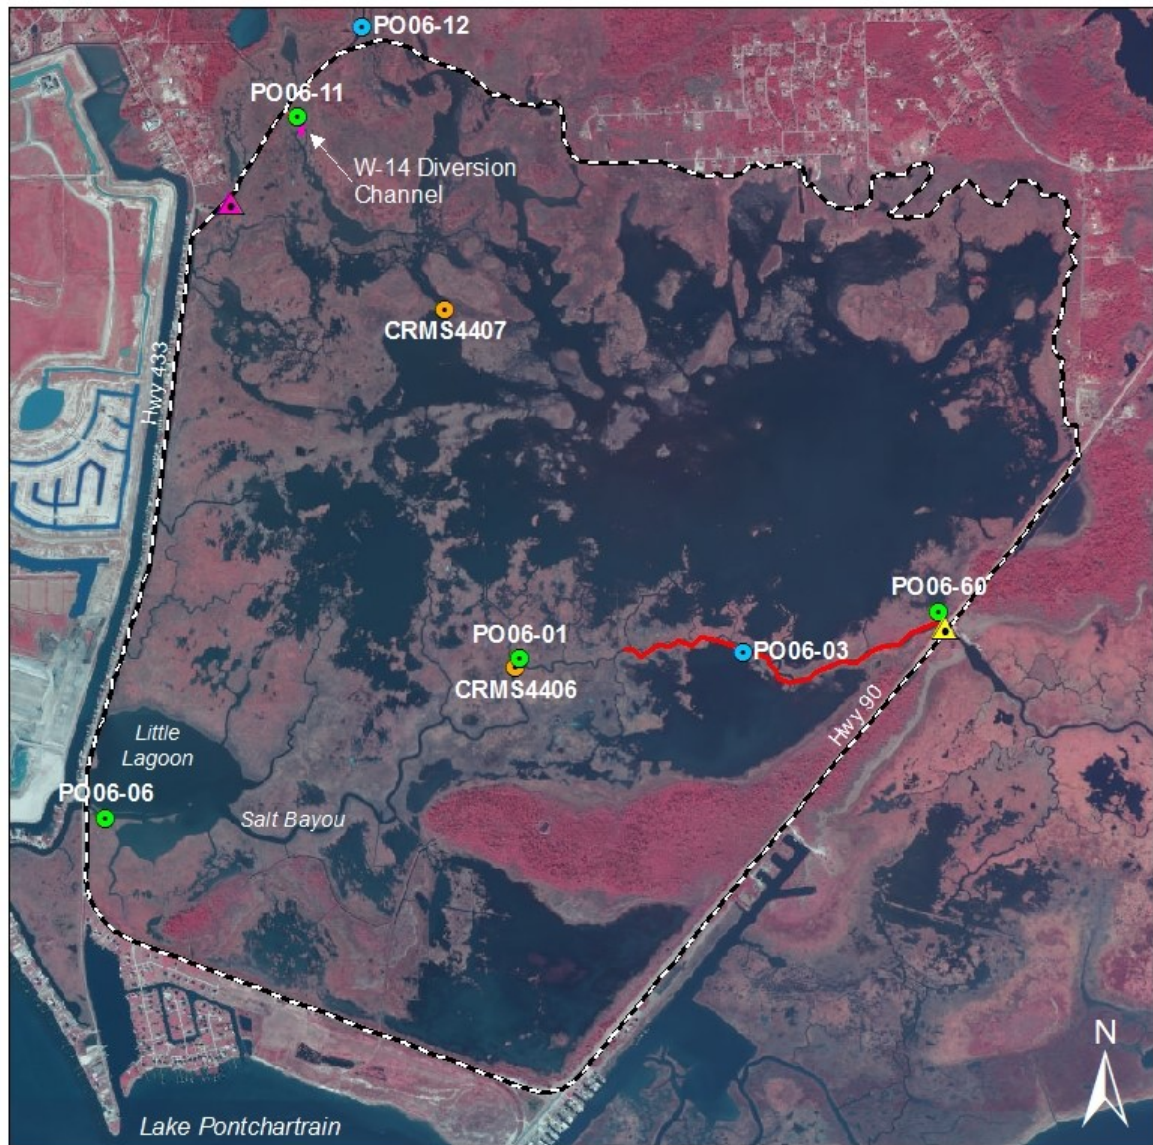
- 72" Concrete Culvert
- Steel Sheetpile Weir with Boat Bay
- PO-06 Continuous Recorder
- CRMS Continuous Recorder
- PO-06 Staff Gauge
- 5,300ft Dredging of Salt Bayou
- 400ft Dredging of W-14 Diversion Channel
- Project Boundary

Figure 1. Fritchie Marsh Restoration (PO-06) project area boundary, construction features, continuous recorder locations, and CRMS site locations.

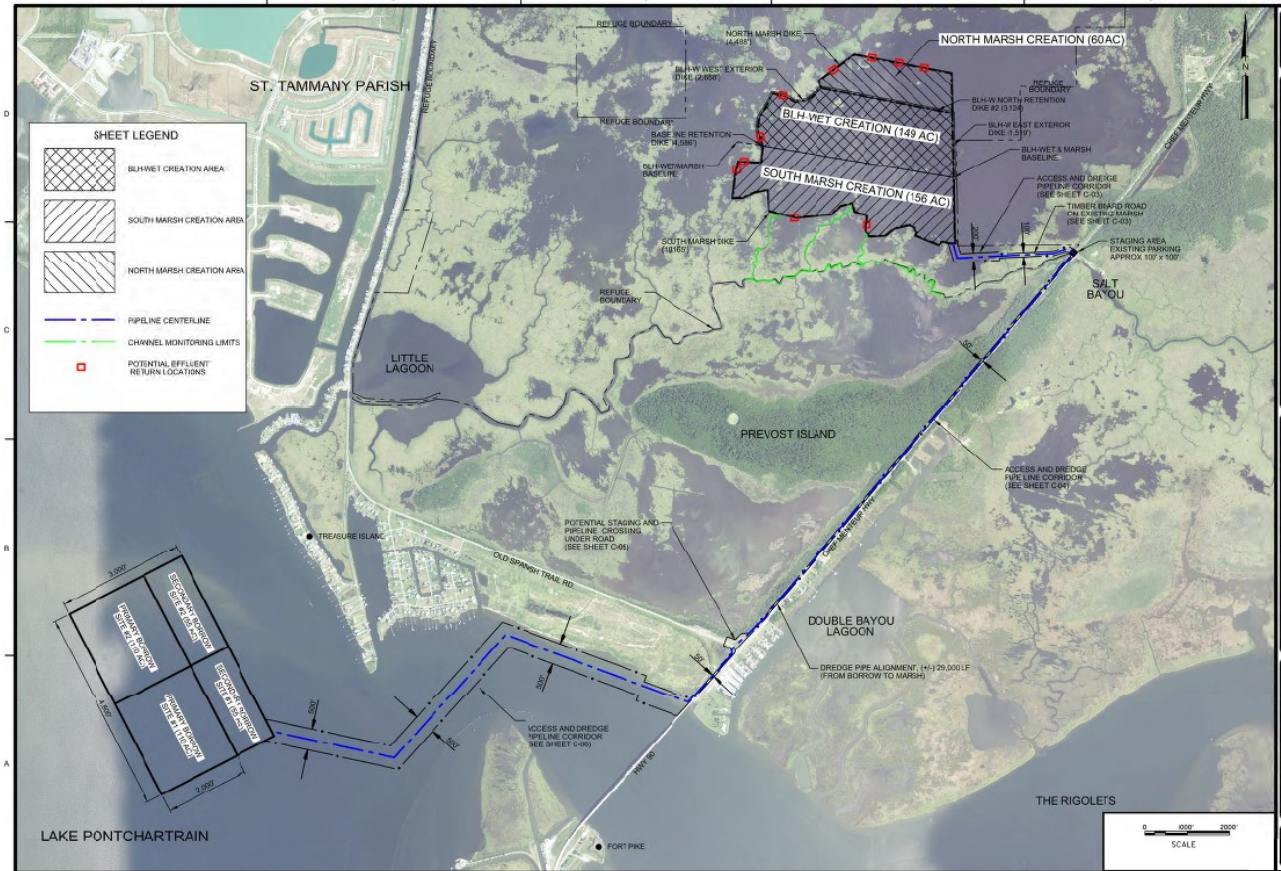
Figure 5. Location of the New Zydeco Ridge BLH-Wet and Brackish Marsh Restoration project area and borrow area. Acreages shown are for the interior fill areas only. Total constructed acreages including degraded containment dikes are expected to be 159 acres BLH-Wet, 62 acres North Marsh Cell, and 160 acres South Marsh Cell.

There are multiple dedicated dredging projects currently in the design and construction stages which will improve land to water ratios within the Fritchie Marsh. At the time of this report, construction of the New Zydeco Ridge BLH-Wet and Brackish Marsh Restoration project is nearly completed, which will directly increase land acreage within the PO-06 project area (Figure 5). This project is being constructed by the USACE to mitigate for impacts associated with construction of the Lake Pontchartrain and Vicinity (LPV) Hurricane Storm Damage Risk Reduction System (HSDRRS). Material dredged from Lake Pontchartrain is being used to create 159 acres of bottomland hardwood habitat flanked by 220 acres of marsh (160 acres to the south and 62 acres to the north) within the shallow, open water area north of Salt Bayou. During project design, it was determined that approximately 2 acres of existing marsh occurred within the proposed project area based on 2013 aerial photography (Trahan 2015). This will result in a net increase of 379 acres of land within the project area following construction. Another CWPPRA project proposed within the PO-06 boundary, the Fritchie Marsh Creation and Terracing project (PO-0173), is in the early design phase and will further increase land acreage within the Fritchie Marsh if constructed (<https://cims.coastal.louisiana.gov/outreach/projects/ProjectView?projID=PO-0173>).

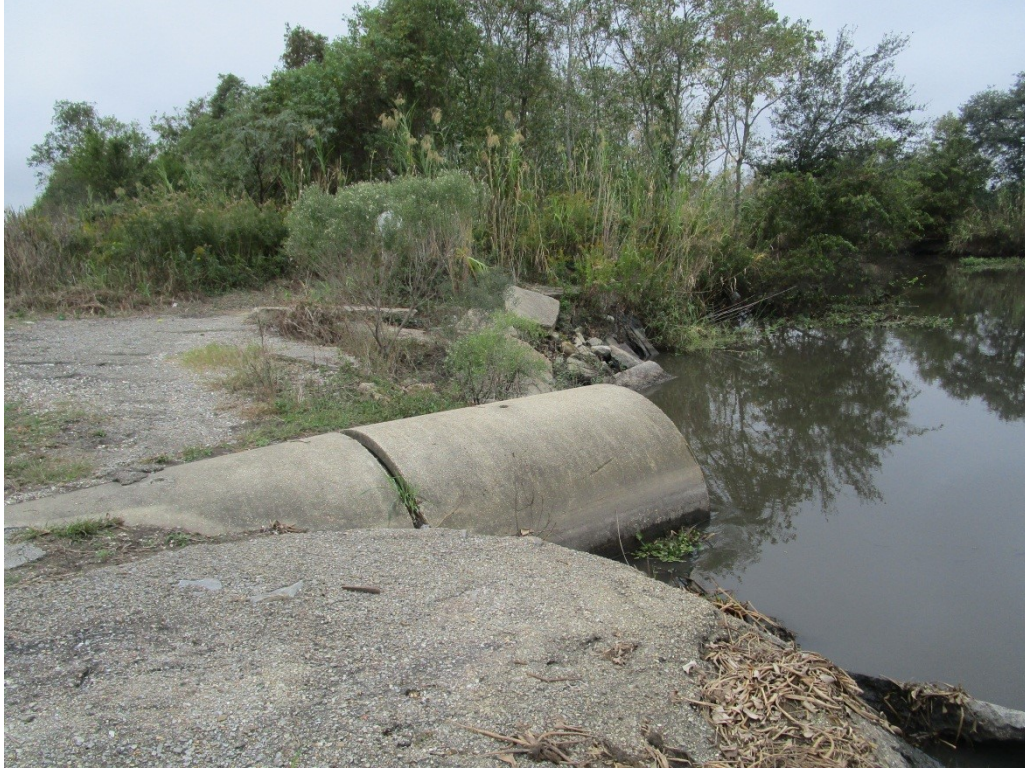
Photo 1: Culverts Beneath Hwy. 90 (West Side)

The joint in the culvert on the dredged side of Salt Bayou (west side of US Hwy 90) appeared to be experiencing some separation (Appendix C: Photos 1 and 2). The bank scour reported in previous inspections appeared to have progressed very little, even with the extremely high water experienced during the spring of 2016.

Due to settlement and separation, the last joint of the culvert on the west side of US Hwy 90 will be removed. Additional riprap armoring will be used to dress the slope to minimize future erosion.

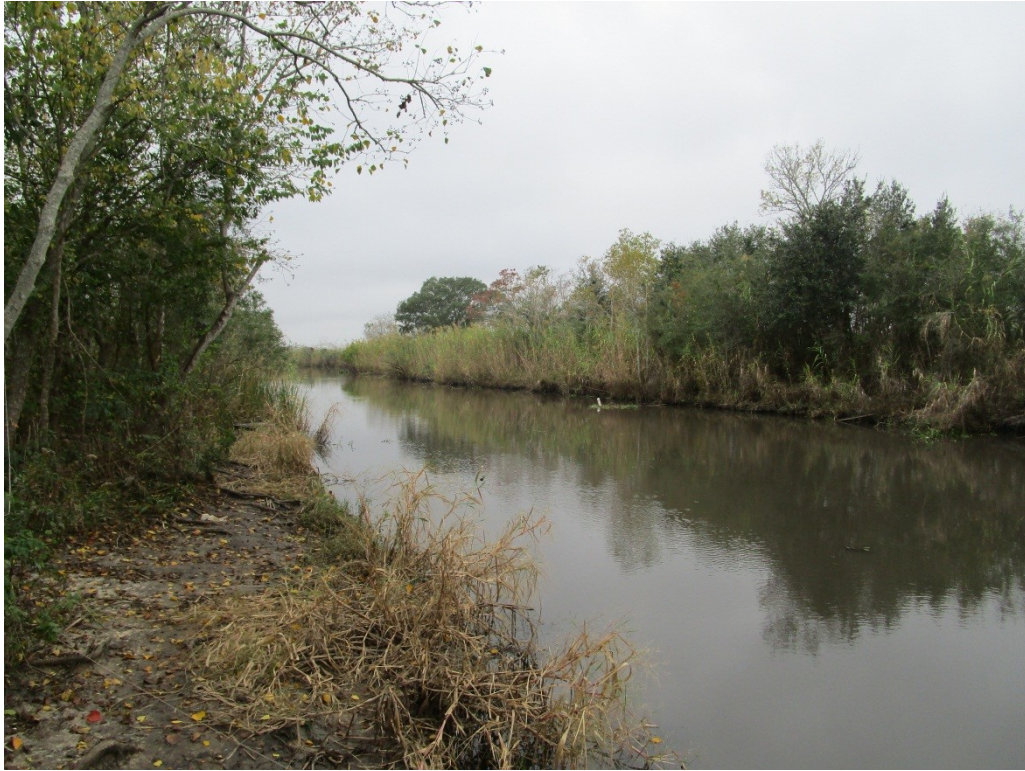
Photo 3: Salt Bayou Flowing West into Project Area (West Side of Hwy 90)

The inspection team was not able to travel west on Salt Bayou from its intersection with US Hwy 90. An inspection in December 2015 noted that significant siltation of the bayou begins approximately 4,500 feet downstream of the culvert (west side of US Hwy 90) and remains shallow for several thousand feet beyond the end of dredging 5,300 feet downstream of the culvert. Due to the noted siltation issue the inspection team was not able to travel on Salt Bayou to observe the dredged section (Appendix C: Photo 3).

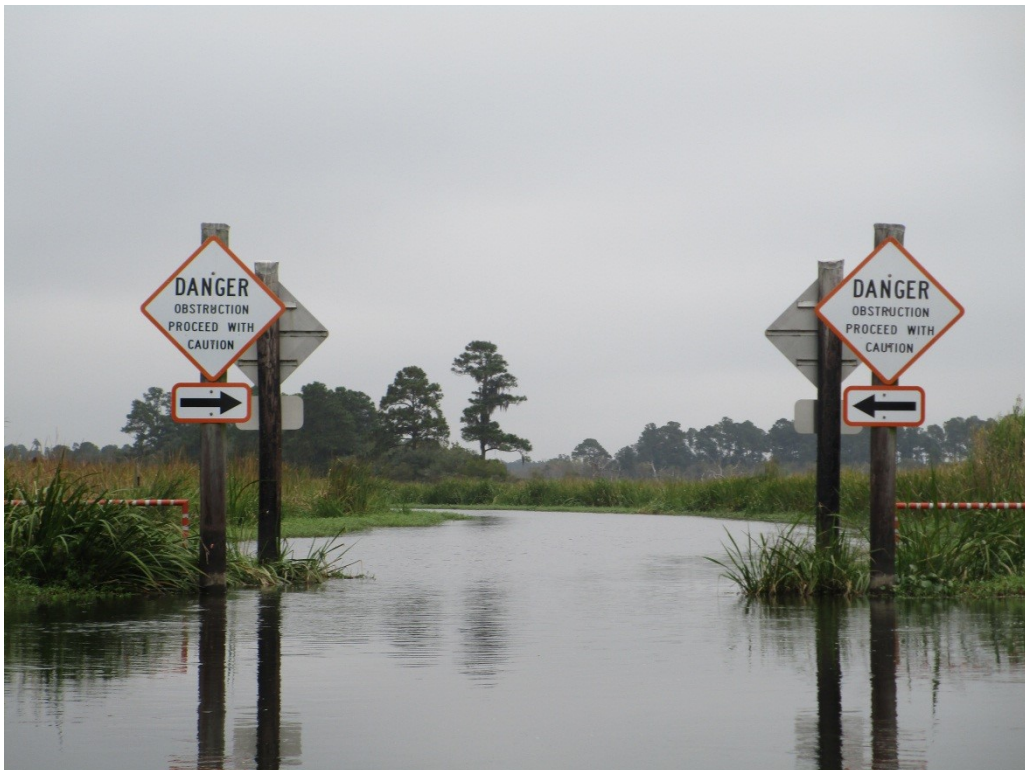
Photo 4: W-14 Canal Weir with Handrails and Warning Signs

The weir structure was mostly surrounded by aquatic vegetation, but the boat bay was navigable. The visible portion of the handrails appeared to be in good condition. The warning signs were in very good condition (Appendix C: Photo 4). No maintenance is required in this area at this time.

Item	Condition	Physical Damage	Corrosion	Photo #	Observations and Remarks
W-14 Weir Handrails, Hardware, etc.	Good	None	None	4	No significant defects noted.
W-14 Weir Signage, Supports	Very Good	None	None	4	Signs and timber support piles appeared to be in very good condition.
Hwy 90 Culvert Riprap Lining	Good	None		1	Good condition. Rip-rap covered by concrete debris on South bank.
W-14 Weir structure	See remarks	See remarks		4	Structure was mostly hidden by emergent vegetation; strong flow was visible in channel.
W-14 diversion channel dredge	Fair	None		5	Channel entrance is filled in and unnavigable due to aquatic vegetation. Emergent vegetation was present in outfall.
Salt Bayou dredging	See remarks	N/A		3	Salt Bayou was deep and unobstructed for about 4,500 feet downstream (marsh side) of culverts at US Hwy 90. Siltation was noted beginning at approx. Sta. 45+00 and continued southwest to Sta. 53+00.

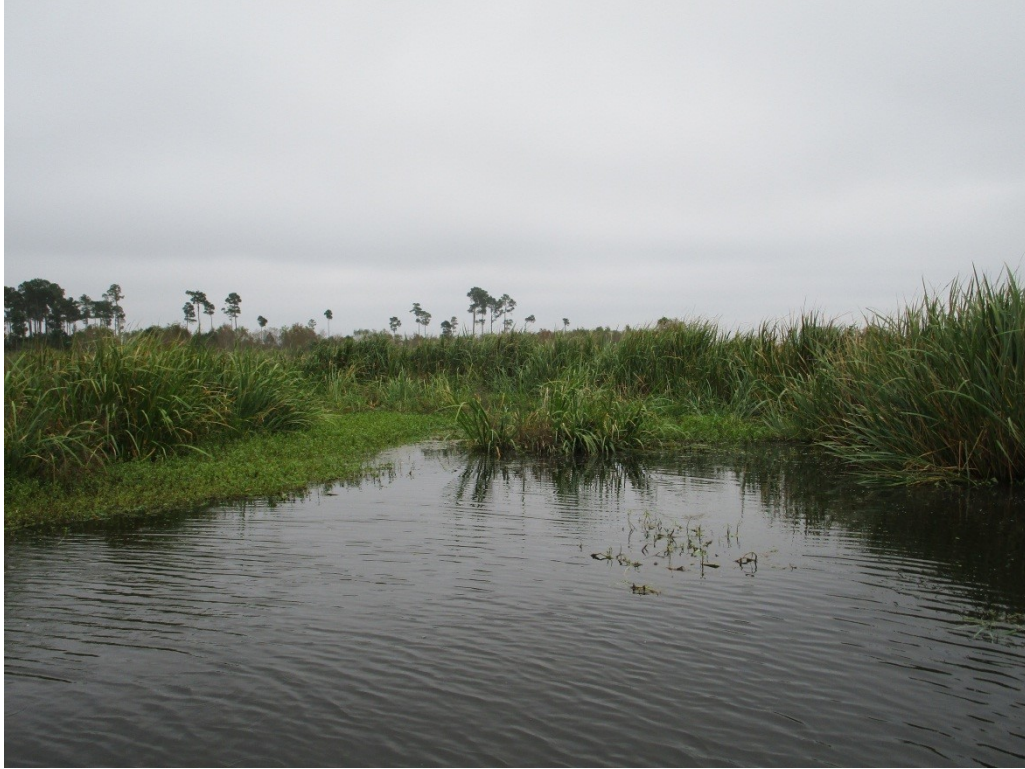
Photo 5: W-14 Diversion Channel Entrance looking from the W-14 Canal

The Diversion Channel is located upstream (north) of the weir and diverts water off of the W-14 Canal to the south through the project area. The inlet of the channel was filled in and unnavigable due to excessive amounts of aquatic vegetation (Appendix C: Photo 5). Emergent aquatic vegetation was present in the channel outfall.

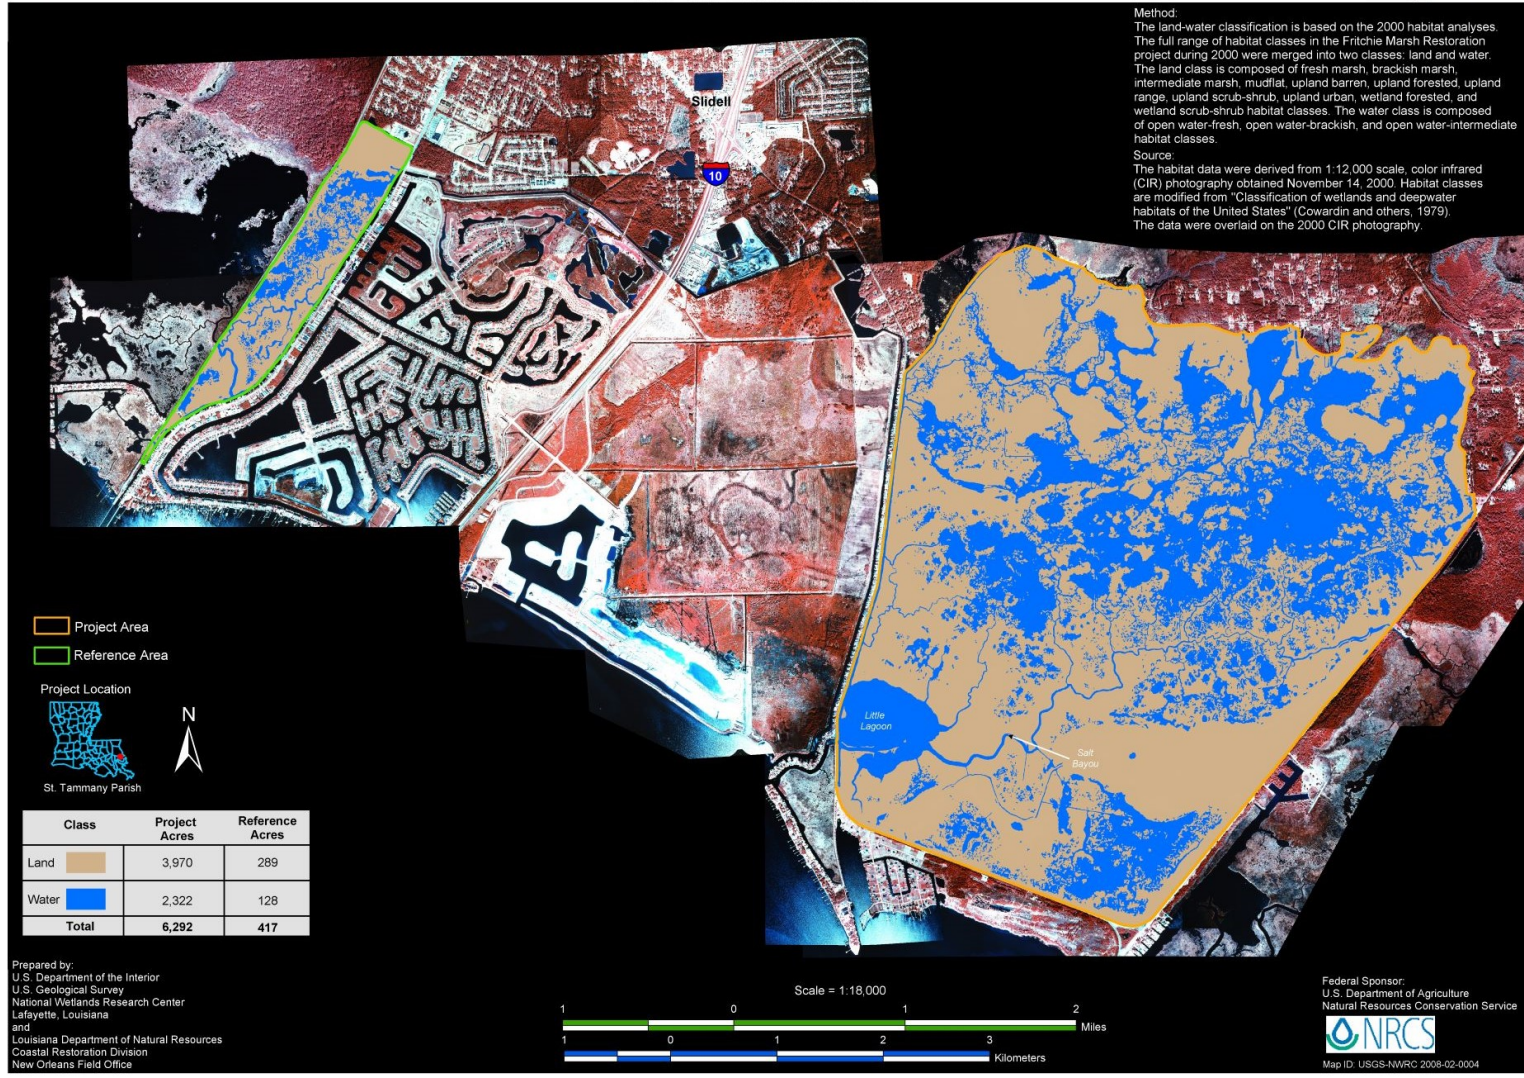
Appendix D2. 2000 land-water classification of the Fritchie Marsh Restoration (PO-06) project and reference areas.

To evaluate land changes within the project and reference areas over time, land/water analyses were conducted in 1996, 2000, 2004, 2010, and 2016 (Appendix D1-D5 and Table 1). There were 126 acres lost during the pre-construction period (1996-2000) at a rate of -32 ac/yr. This observed loss rate was 54% lower than the historic loss rate assumed during the WVA process, and may be a more accurate representation of land loss conditions just before the start of project construction. Total land acreage in 2000 within the project area just before the start of construction was 3,970 acres (63% of the total acreage), and the WVA land loss rates were applied to this observed ‘Year 0’ land acreage to project the ‘Future With Project’ and ‘Future Without Project’ acreages (Figure 2).
